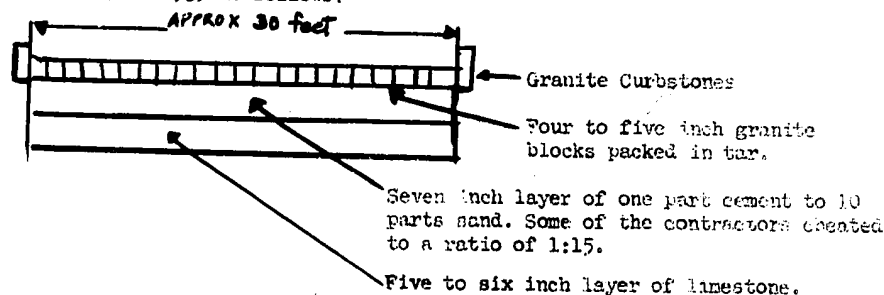
2. Most of the streets shown in the sketch were reconstructed during the period 1933 to 1939 as follows: -

There were a few streets made of macadam over limestone. The sidewalks were of limestone about four and one half inches thick and about one yard square.
